From Response to Recovery – The Story of the 2013 Colorado Floods as Experienced by the Colorado Division of Water Resources Dam Safety Branch

By: All 12 Members of the Colorado Dam Safety Branch

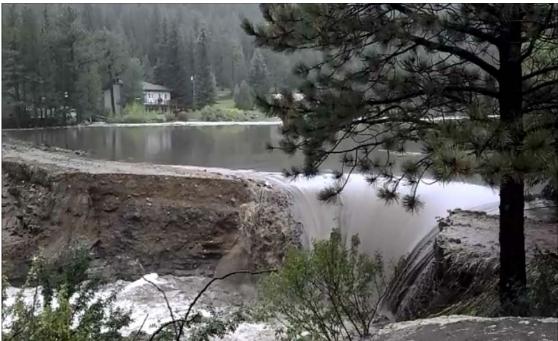
A return phone call from Mr. Arnold around 10:00 A.M. confirmed that the upper most dam (Sunset Lake) had given way around 8:00 A.M. The remaining dams were overtopping by several feet of water but remained intact. Mr. Arnold called back at approximately 12:30 P.M. to say that he just witnessed the failure of Willow Lake and Rainbow Lake dams. Mr. Arnold recounted the failure of Rainbow Lake saying, "I have never seen anything like this before, the dam just opened up." At this time Mirror Lake and Meadow Lake were still intact. It was assumed that all the dams below would fail as a result, but the Meadow Lake dam held on for another hour, and Mirror Lake held on until about 2:00 A.M. the next morning.

Figure 4 - Photo of Meadow Lake dam as the full breach develops at 1:40 P.M. on Thursday September 12.

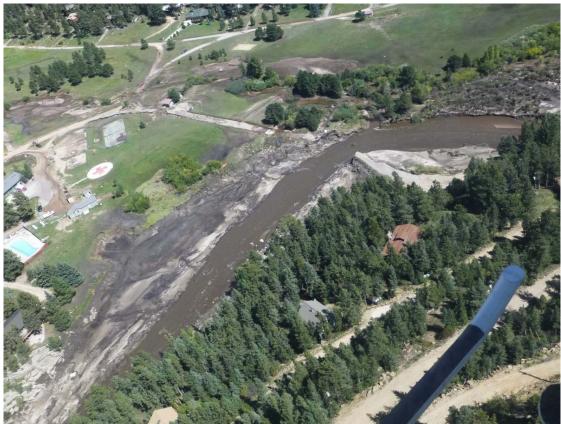
Figure 5 - Photo of main access to Big Elk Meadows subdivision over the Mirror Lake dam, taken from the air on September 17..

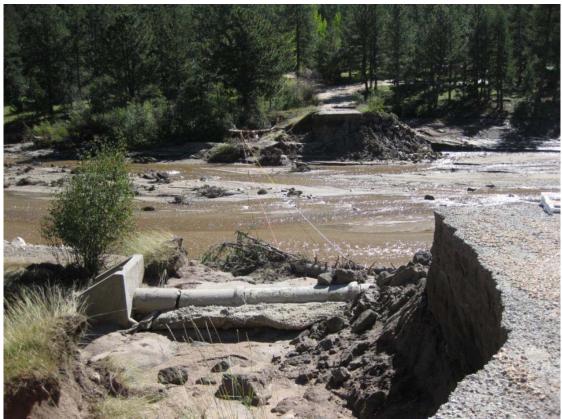
Figure 6 - Photo of the Rainbow Lake dam breach taken on September 25, after 12 days of continuous high flows.

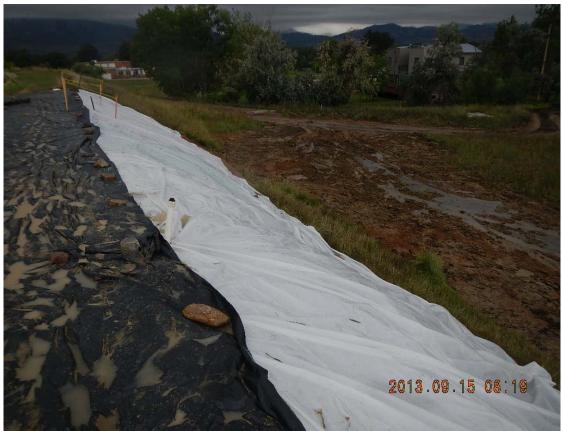
The first step involved assessing conditions at the Northwest Dam. As they assess the numerous apparent issues, they quickly focus on the 40-foot long, 1-foot high slump at the downstream shoulder. Initial mitigation recommendations to minimize continued destabilization of the slope included establishment of crest drainage to the upstream slope (away from the downstream slump), covering the downstream slope with tarps to minimize continued slope saturation, and establishment of makeshift monitoring systems to quickly detect future slope movement.

Figure 7 - Temporary stabilization measures along the reach of the downstream slope that had sloughed at Baseline dam.

Due to quick action of the owner and engineers and to the great relief of all involved, the dam was able to "weather the storm." Digitally accessible state dam files, and the 24-hour monitoring and inspection were huge contributors to the successful outcome of a very stressful situation. However, weaknesses were revealed and a frightening nearmiss was recorded. This situation has also highlighted another potential failure mode that should be considered when evaluating dam designs – intense, sustained rainfall leading to increased pore water pressure in the downstream shell, resulting in slope instability.

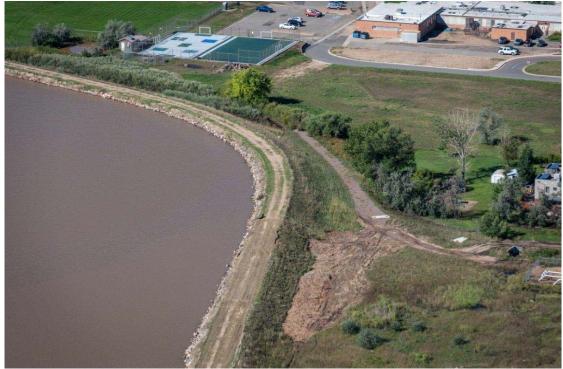
Figure 8 - Aerial photo of the Baseline Northwest dam with temporary stabilization measure in place and a declining reservoir level.

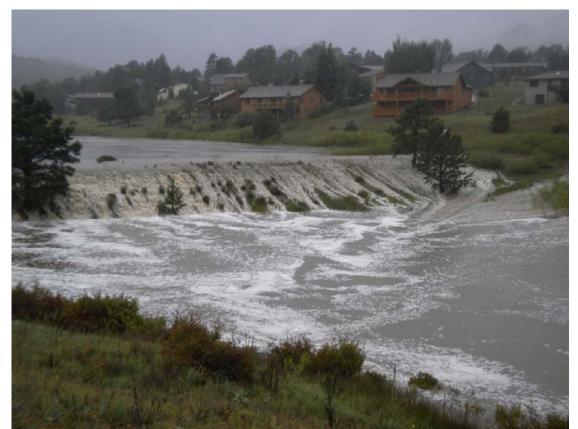
Overtopping began on Thursday morning. Based on DSB forensic investigation the Carriage Hills No. 2 Dam (lower dam) failed around 10 P.M. on Thursday or early morning (2-3 A.M.) on Friday. Thankfully, no loss of life or significant property damage was documented as a result of the dam failure.

Figure 9 - Photo of Carriage Hills No. 1(upper dam) overtopping taken on Thursday September 12, 2013 by an Estes Park resident.

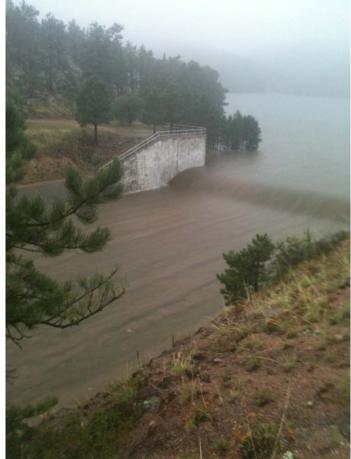
Figure 12 - Photo of Button Rock dam spillway flow from the left abutment, near peak (10,000 cfs) on Friday September 13, 2013.

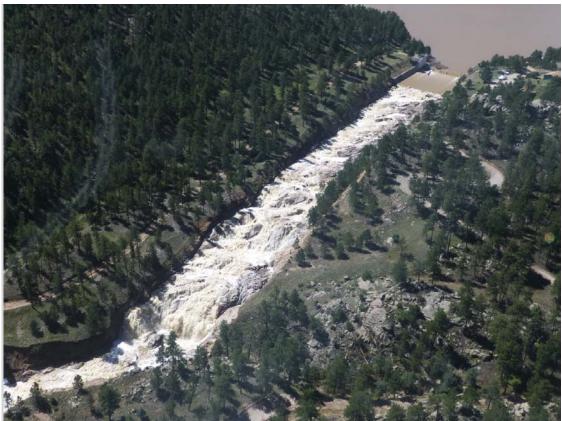
Based on review of the geology, spillway design drawings and visual examination of the concrete spillway structure and downstream rock channel from the air, it was determined the channel is well armored by bedrock and was performing as designed. Erosion was occurring at the bottom of the spillway channel but was not endangering the structure or the dam. A significant log jam was noted in the upstream end of the reservoir which was identified as a potential safety issue during the upcoming spring runoff and was made a priority to be removed over the winter.

Figure 13 - Button Rock dam spillway flows from the air on September 16, 2013.

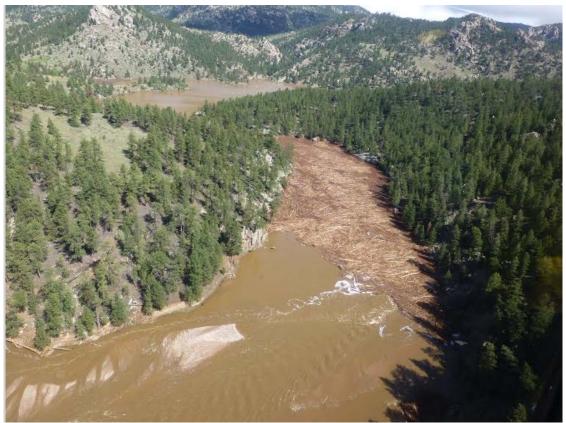
Figure 14 - Button Rock reservoir with log jam from the air on September 16, 2013.

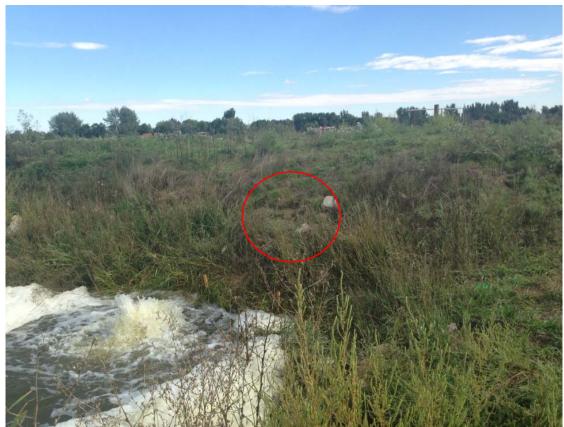
On Monday Johnny Batka is notified by Karen Martinez from Boulder County Open Space of a sinkhole that had formed over the downstream end of the outlet conduit at Gaynor Lake dam, which is classified a Significant hazard dam.

The heavy rainfall that occurred over the Longmont area between September 11, and 15, caused a significant amount of runoff to enter the reservoir which was passed through the reservoir via the service spillway and outlet conduit. With the amount of uncontrolled flow through the outlet conduit, water in the outlet ditch inundated the downstream outlet structure causing a sinkhole to form approximately halfway up the embankment. The cause of the sinkhole is not known, but it was likely caused by a combination of pressurized flow in the outlet pipe combined with a pipe defect and saturation of the embankment due to the water backing up in the outlet ditch. A defective joint in the vicinity of the outlet likely allowed the saturated embankment material to migrate into the conduit causing the sinkhole to form on the surface of the embankment.

Figure 14 - Photo of the swollen outlet channel at Gaynor Lake dam. Note location of sinkhole above the pipe.

With Johnny dealing with the questions about Button Rock Dam, Erin Gleason helps the owner gain control of the situation. Approximately 300 feet of the outlet ditch was cleaned with a large tracked excavator to improve the flow conditions, and a gravel filter was placed on the downstream slope over the sinkhole to slow the loss of embankment material. As the inflow in the reservoir decreased the outlet valve was opened to lower the reservoir level. The dam was monitored daily by Boulder County Open Space and DWR staff until it was lowered to a safe level. The reservoir was eventually drained completely.

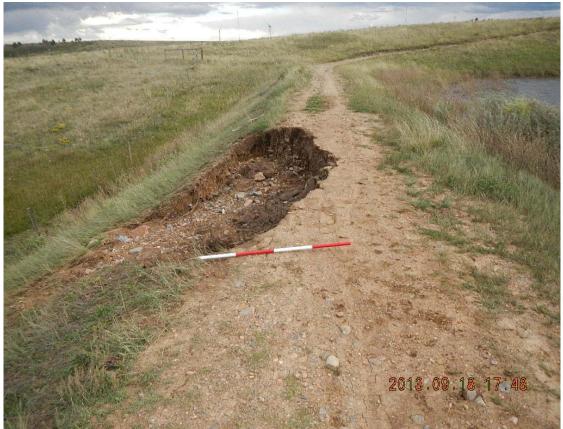
Figure 16 - Photo of a slope failure caused by embankment saturation due to overtopping of the Flatirons Vista dam. The weakened dam was eventually breached.

Over the next few weeks, the inoperable upstream outlet gate was removed and the reservoir was allowed to drain down to near the outlet elevation, and the breach depth was increased to approximately 1-2 feet above the outlet crown.

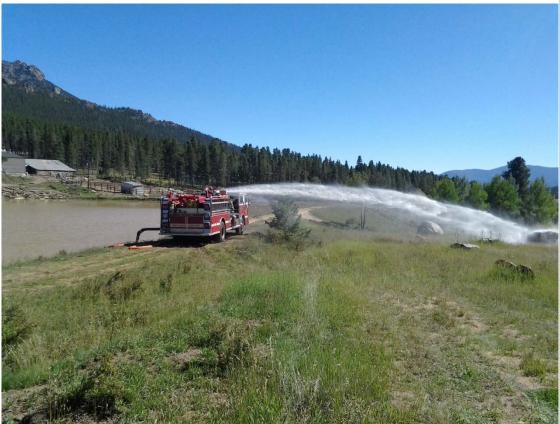
Figure 17 - Photo of fire truck utilized as a last resort to begin to lower reservoir level at Aspen Lodge dam.
