DAM SAFETY IN THE NORTHEAST: RESPONSE TO HURRICANE IRENE & TROPICAL STORM LEE FLOOD EVENTS

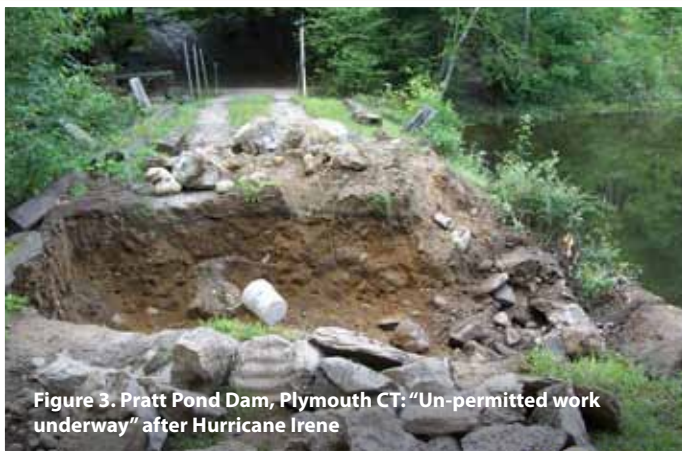
Figure 3. Pratt Pond Dam, Plymouth CT: "Un-permitted work underway" after Hurricane Irene

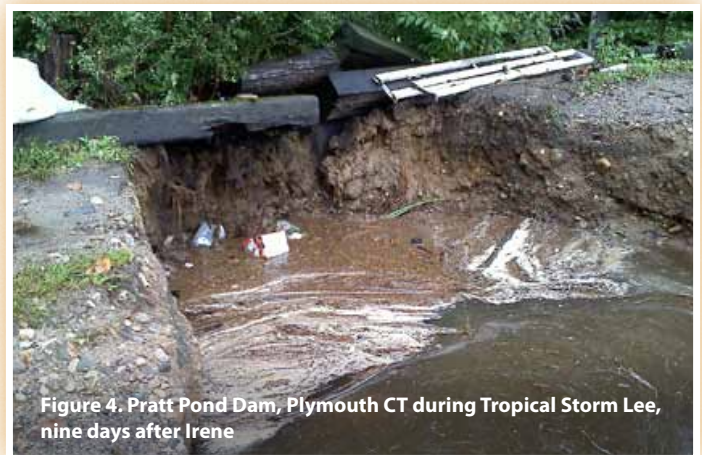
Figure 4. Pratt Pond Dam, Plymouth CT during Tropical Storm Lee, nine days after Irene

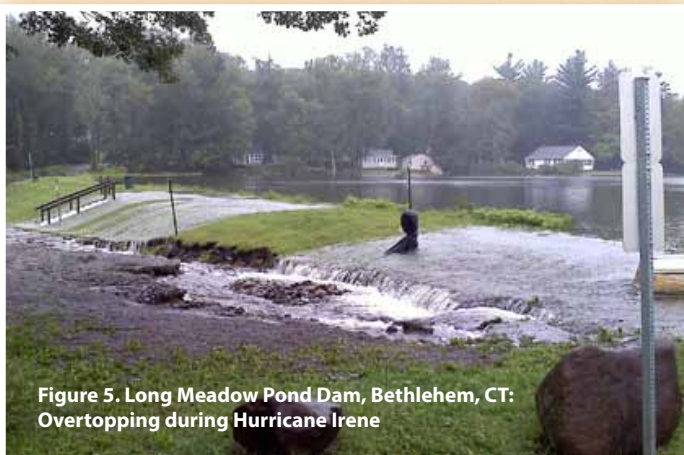
Figure 5. Long Meadow Pond Dam, Bethlehem, CT: Overtopping during Hurricane Irene

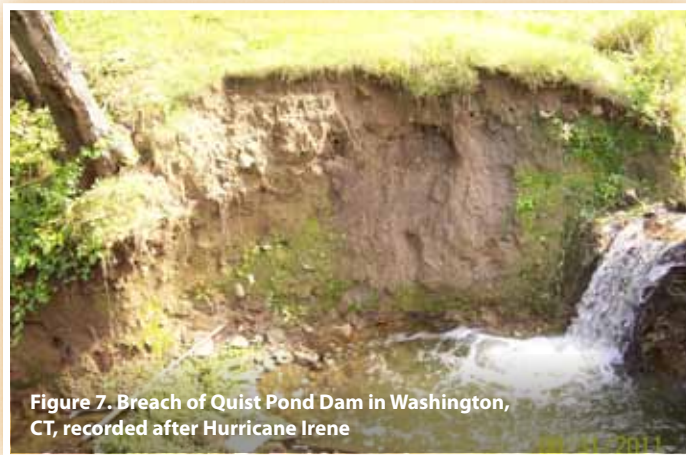
Figure 7. Breach of Quist Pond Dam in Washington, CT, recorded after Hurricane Irene

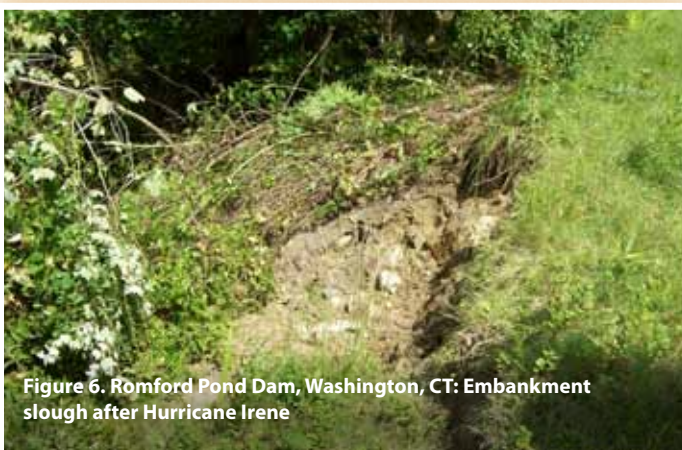
Figure 6. Romford Pond Dam, Washington, CT: Embankment slough after Hurricane Irene

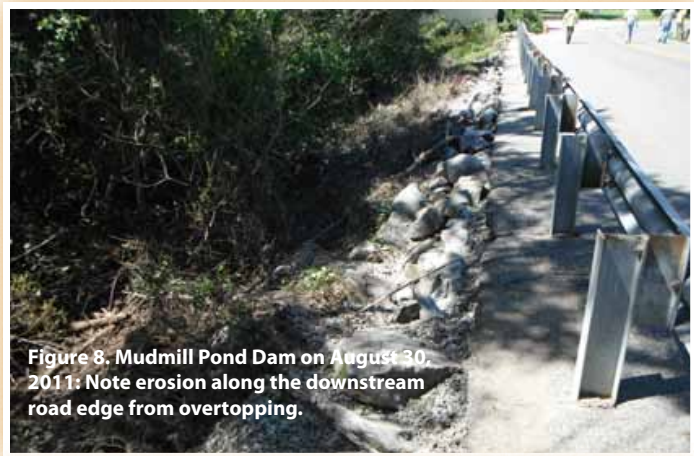
Between August 23 and 26, crews removed flashboards at 25 to 30 dams across the state. During the storm, only three state-owned dams overtopped, with minor damage at two dams (Mudmill Pond Dam and Garrisons Lake Dam, Figures 8-9) and no significant damage at the third dam (Masseys Mill Dam, Figure 10). All three dams that overtopped are located in Kent County, near where some of the highest rainfall amounts were recorded. This part of the state had experienced heavy rains in the weeks prior to Irene, and the ground was already saturated. Masseys Mill Dam is located upstream of Garrisons Lake Dam in the same watershed, and it is likely that the overtopping of Masseys Mill Dam caused Garrisons Lake Dam to overtop, although the overtopping of Masseys Mill occurred before daylight on August 28 and was not reported or apparently witnessed. Between August 28 and 30, DNREC and DelDOT inspected and completed damage assessments for all 42 state-owned dams.

Figure 8. Mudmill Pond Dam on August 30, 2011: Note erosion along the downstream road edge from overtopping.

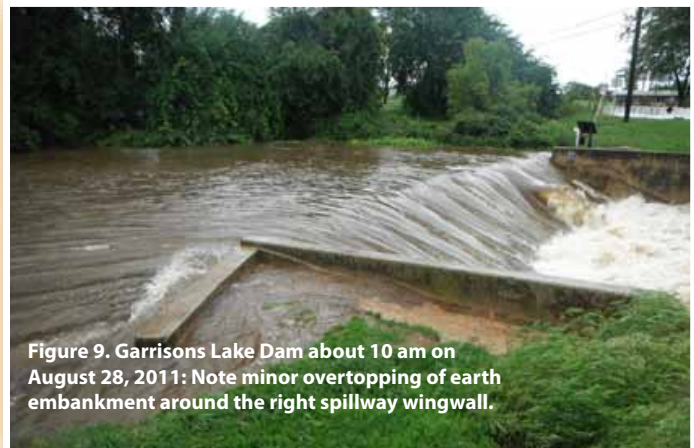
Figure 9. Garrisons Lake Dam about 10 am on August 28, 2011: Note minor overtopping of earth embankment around the right spillway wingwall.

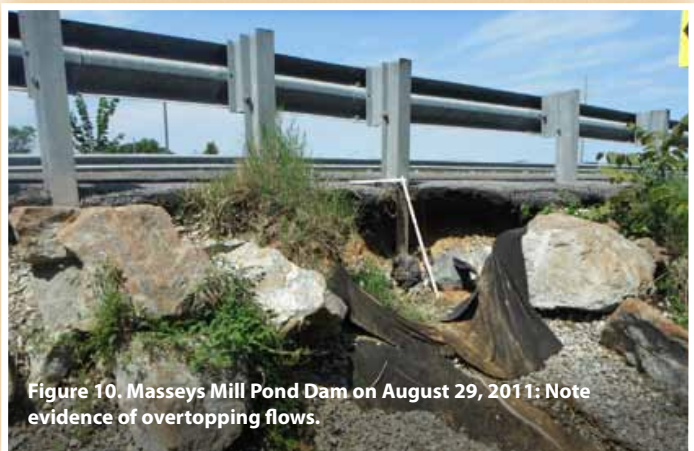
Figure 10. Masseys Mill Pond Dam on August 29, 2011: Note evidence of overtopping flows.

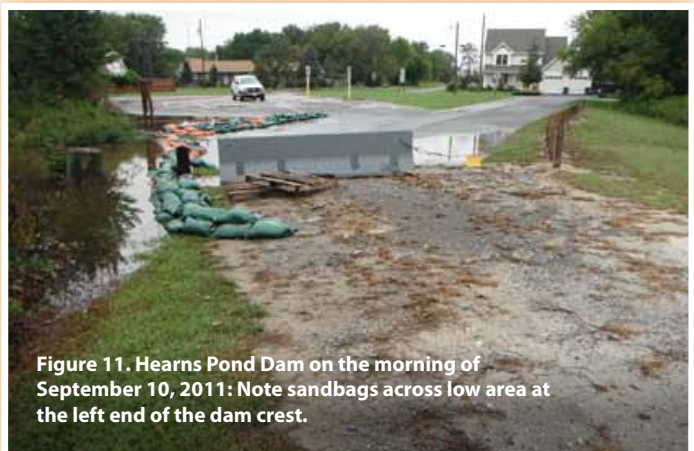
DNREC and DelDOT staff arrived at Hearn's Pond Dam about 5 pm and found that the pond water level was about 1.5 feet above normal pool, leaving about six inches of freeboard prior to overtopping. The heavy rainfall had stopped, but the pond level was visibly rising, by four to five inches per hour. Prior to Hurricane Irene, DelDOT had pre-positioned filled sandbags at state maintenance yards, one of which is less than a mile from the dam. The sandbags, unused during Irene, were now put to use. DelDOT personnel delivered pallets of sandbags to the dam, where they were placed in two low spots along the crest in an effort to keep the embankment from overtopping.

Figure 11. Hearn's Pond Dam on the morning of September 10, 2011: Note sandbags across low area at the left end of the dam crest.

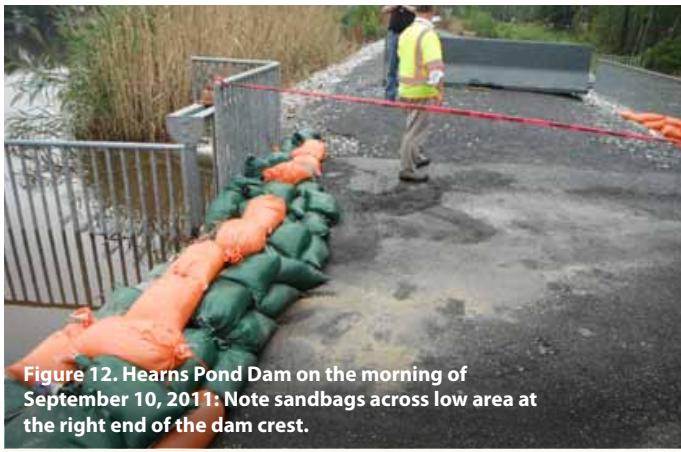
Figure 12. Hearn's Pond Dam on the morning of September 10, 2011: Note sandbags across low area at the right end of the dam crest.

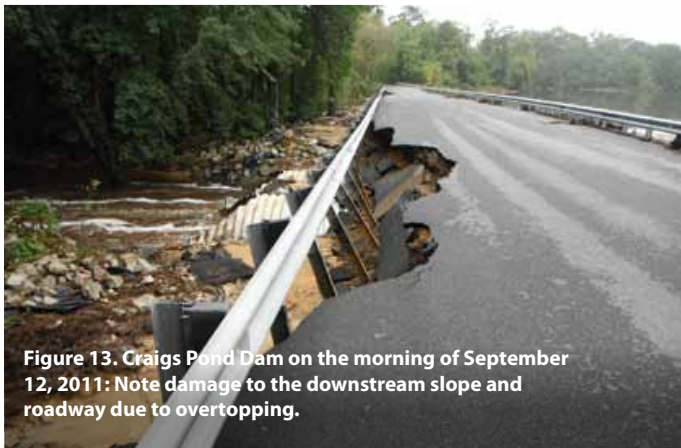
During Tropical Storm Lee it was reported that the water level on Craigs Mill Road, which runs along the dam crest, was higher than the top of the guardrail along the road, (the top of the guardrail is typically about thirty inches above the road). It is unknown how long the overtopping continued at Craigs Pond Dam, but the roadway was significantly damaged and remained closed for several weeks after the storm. Road repairs cost approximately \$300,000 (Figure 13).

Figure 13. Craig's Pond Dam on the morning of September 12, 2011: Note damage to the downstream slope and roadway due to overtopping.

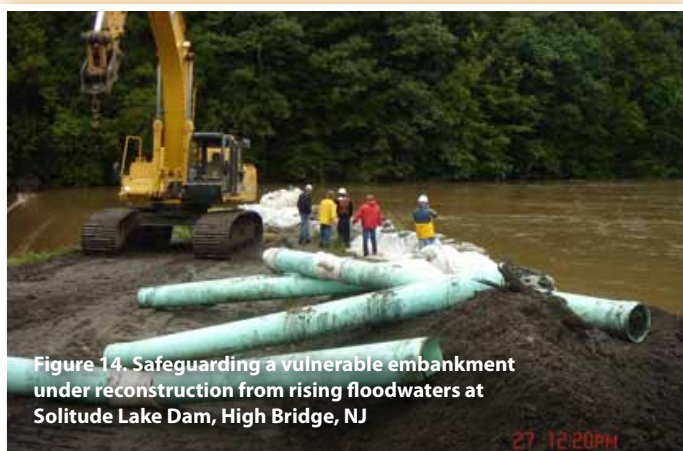
Figure 14. Safeguarding a vulnerable embankment under reconstruction from rising floodwaters at Solitude Lake Dam, High Bridge, NJ

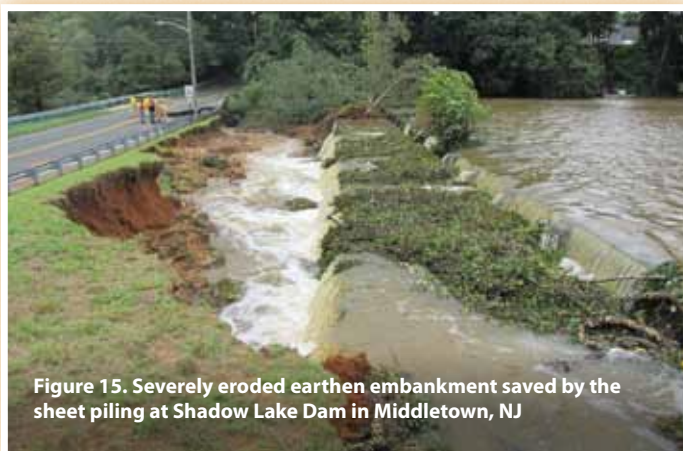
Figure 15. Severely eroded earthen embankment saved by the sheet piling at Shadow Lake Dam in Middletown, NJ

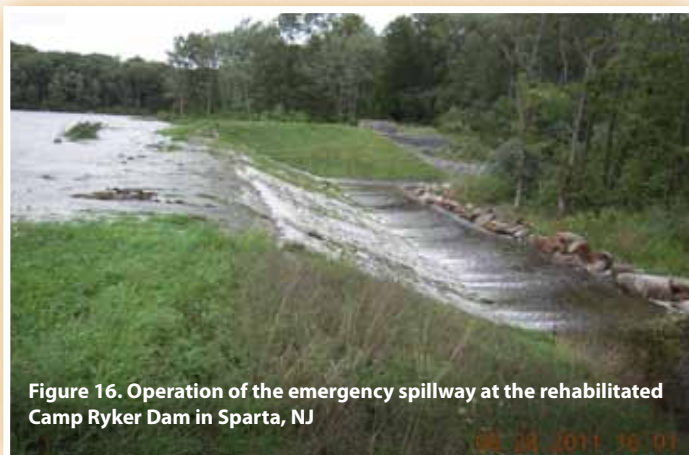
Figure 16. Operation of the emergency spillway at the rehabilitated Camp Ryker Dam in Sparta, NJ

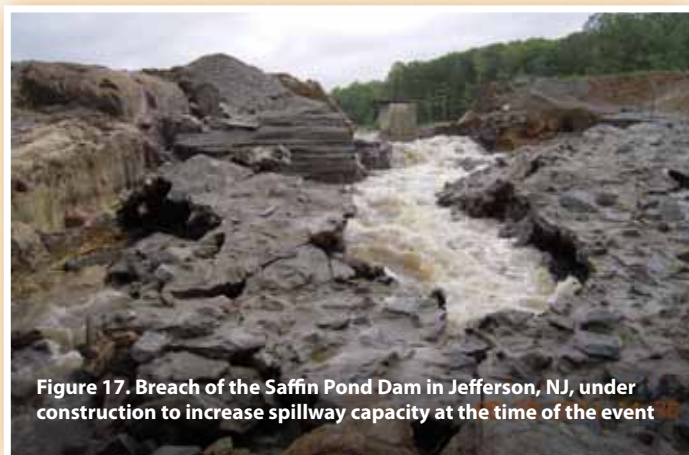
Figure 17. Breach of the Saffin Pond Dam in Jefferson, NJ, under construction to increase spillway capacity at the time of the event

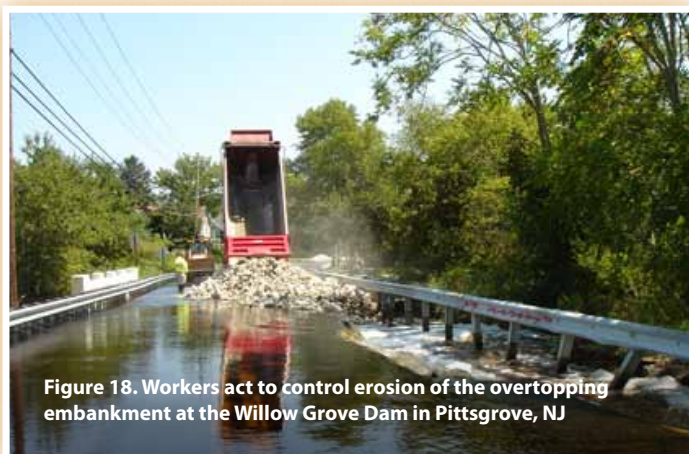
Figure 18. Workers act to control erosion of the overtopping embankment at the Willow Grove Dam in Pittsgrove, NJ

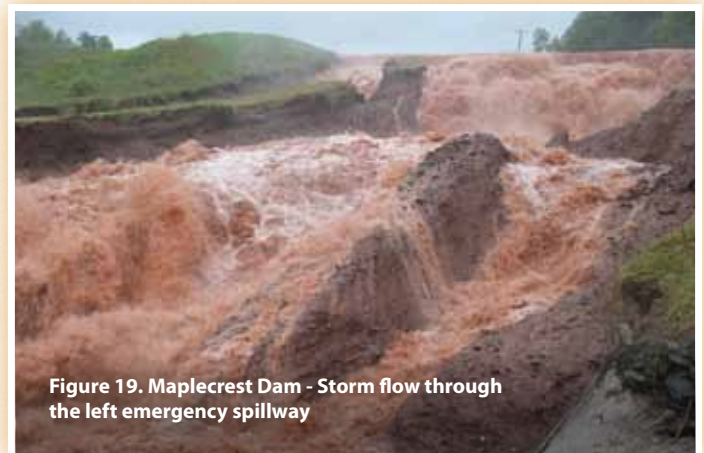
Figure 19. Maplecrest Dam - Storm flow through the left emergency spillway

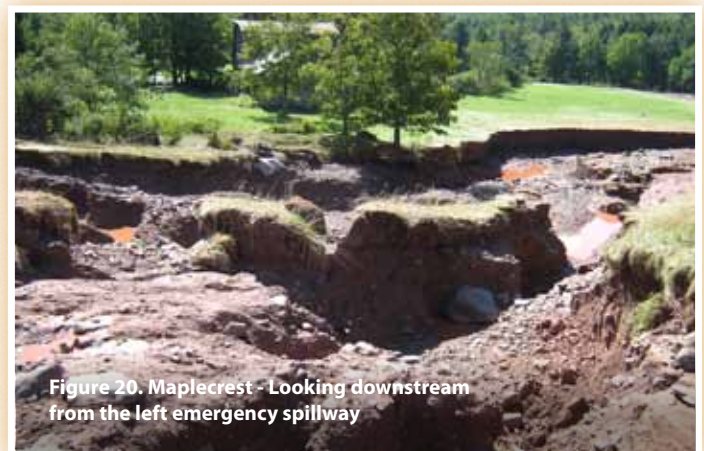
Figure 20. Maplecrest - Looking downstream from the left emergency spillway

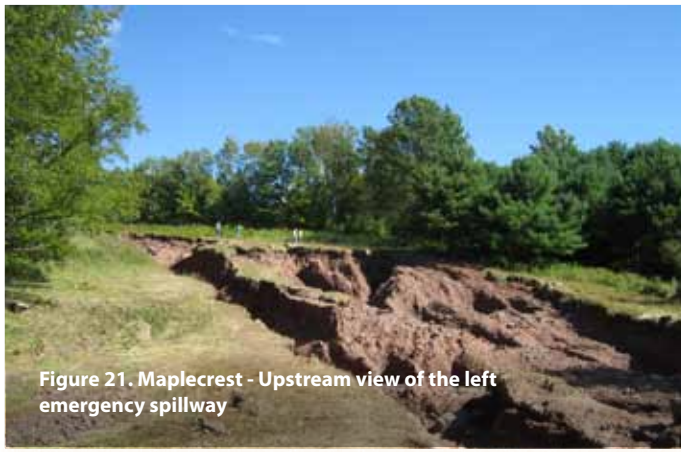
Figure 21. Maplecrest - Upstream view of the left emergency spillway

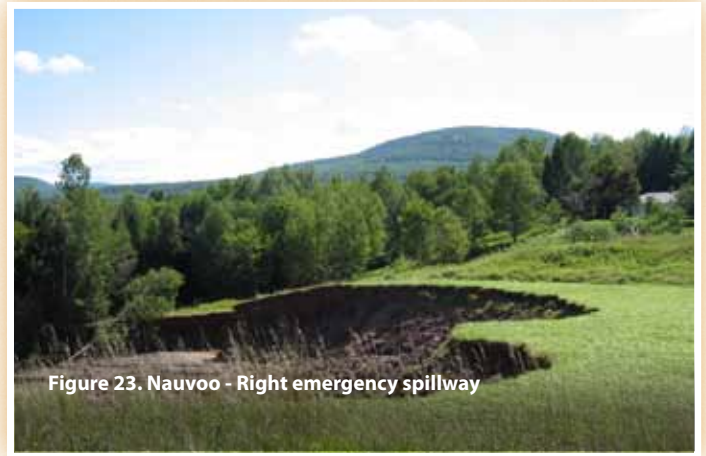
Figure 23. Nauvoo - Right emergency spillway

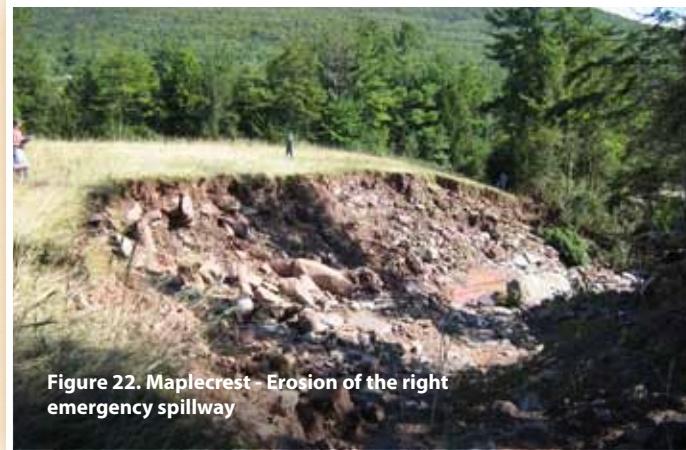
During the flooding resulting from Hurricane Irene, all three dams' emergency spillways activated, resulting in erosion in the right and left spillways at Maplecrest and Mitchell Hollow, and in the left spillway at Nauvoo (Figures 19-28). The erosion to Maplecrest and

Figure 22. Maplecrest - Erosion of the right emergency spillway

Nauvoo dams was serious enough to warranted emergency repairs to provide protection during future flood events through spring 2012. Long-term repairs will be made in the summer of 2012.

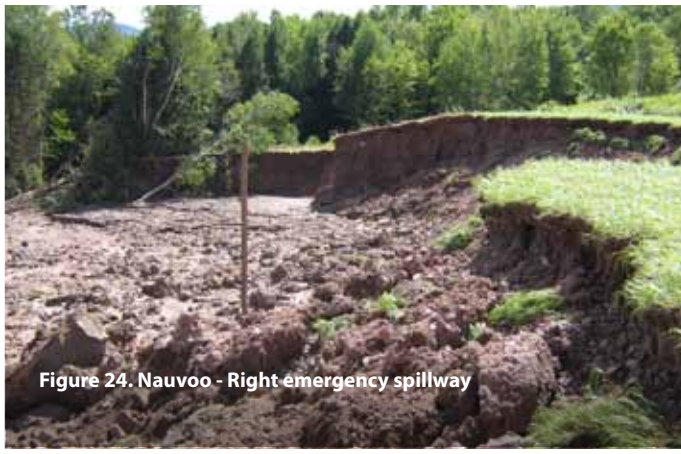
Figure 24. Nauvoo - Right emergency spillway

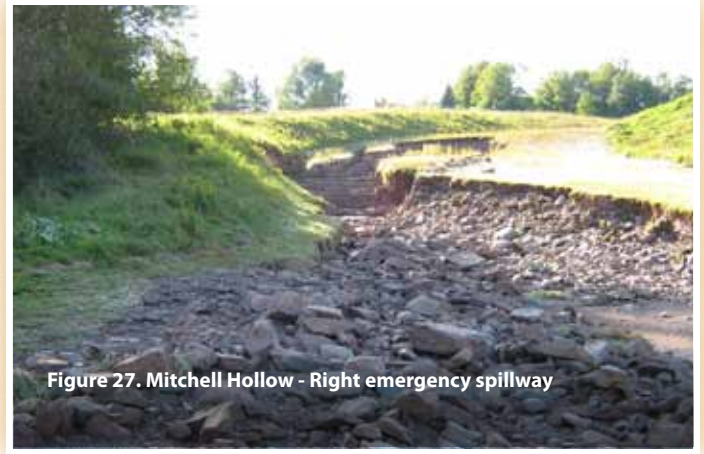
Figure 27. Mitchell Hollow - Right emergency spillway

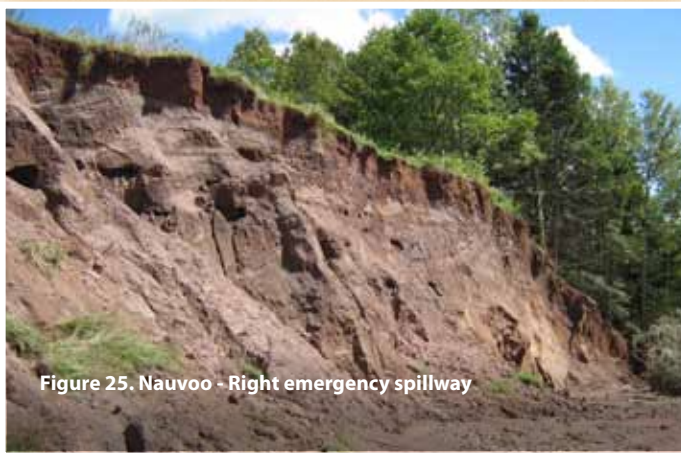
Figure 25. Nauvoo - Right emergency spillway

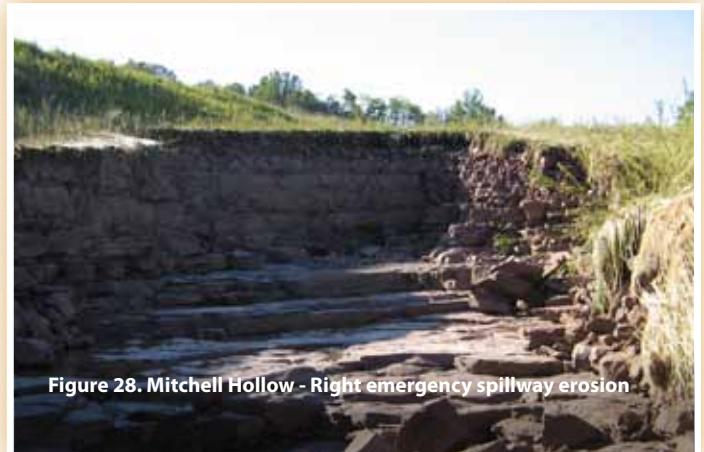
Figure 28. Mitchell Hollow - Right emergency spillway erosion

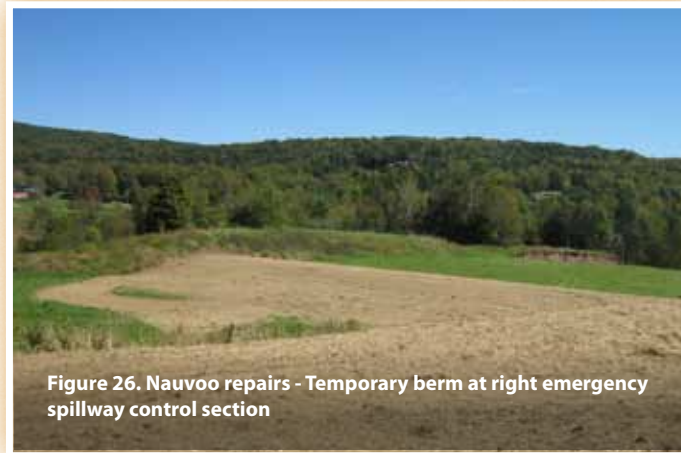
Figure 26. Nauvoo repairs - Temporary berm at right emergency spillway control section

Emergency authorizations were issued for work at Nauvoo and Maplecrest Dams following the storms. At Nauvoo, a temporary emergency berm was constructed in the right emergency spillway to prevent further flow through the spillway. At Maplecrest, reconstruction to repair the erosion in the emergency spillways was significantly completed. Work at all three dams will re-commence in the spring 2012 to complete the rehabilitation of the eroded areas.

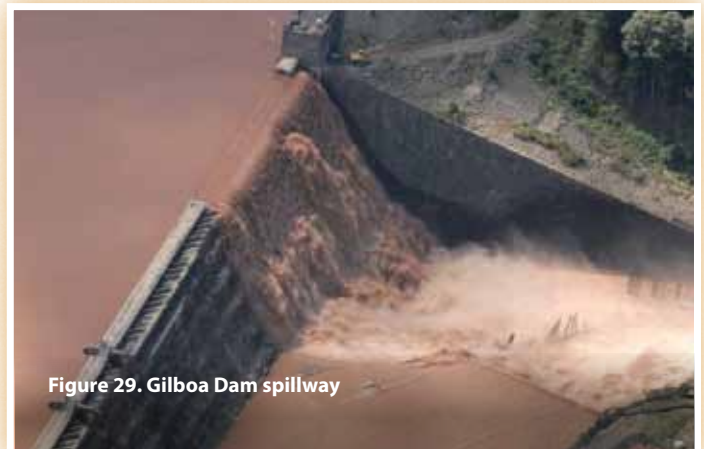
Figure 29. Gilboa Dam spillway

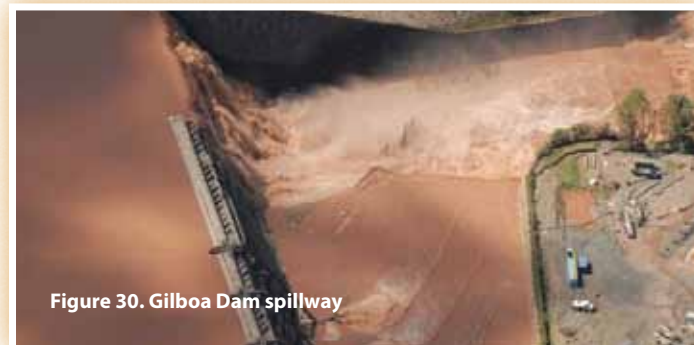
Figure 30. Gilboa Dam spillway

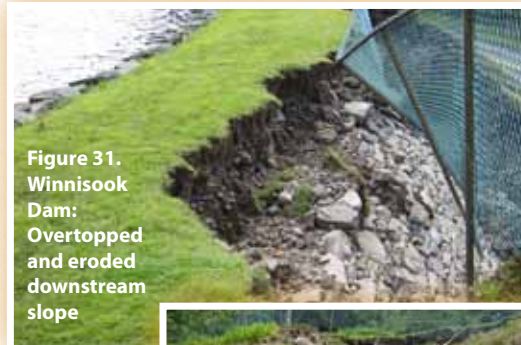
Figure 31.
Winnisook
Dam:
Overtopped
and eroded
downstream
slope

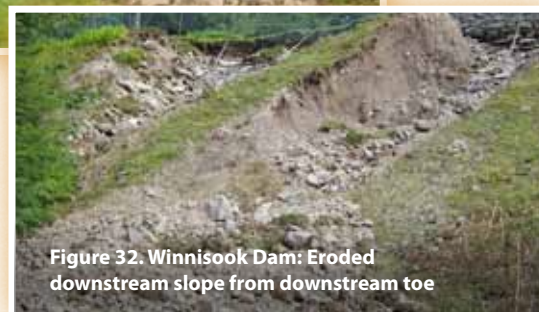
Figure 32. Winnisook Dam: Eroded
downstream slope from downstream toe

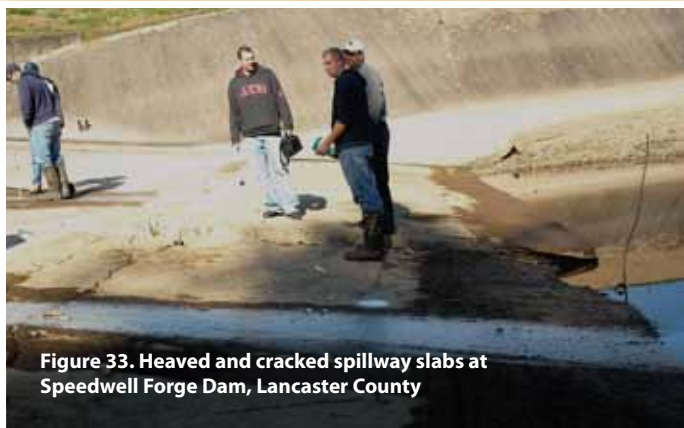
Figure 33. Heaved and cracked spillway slabs at Speedwell Forge Dam, Lancaster County

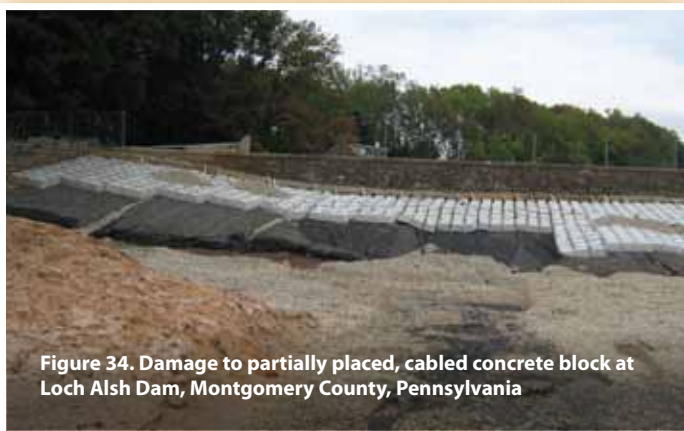
several times before, local responders indicated that this flood overtopped the dam by the greatest depth in recent memory. The partially constructed block layer was damaged (Figure 34).

Figure 34. Damage to partially placed, cabled concrete block at Loch Alsh Dam, Montgomery County, Pennsylvania

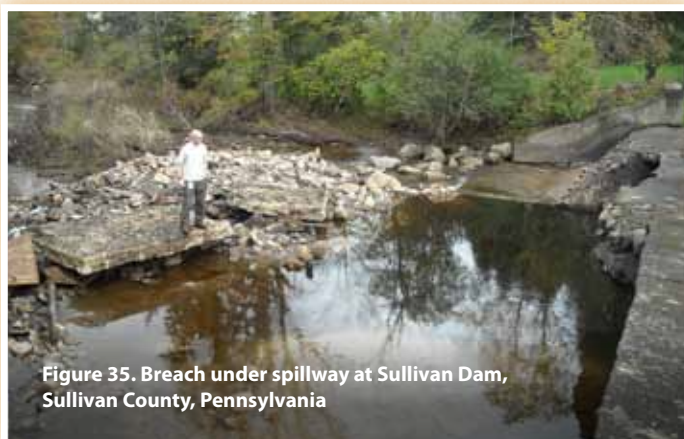
Figure 35. Breach under spillway at Sullivan Dam, Sullivan County, Pennsylvania
