Spillway Chute Joints – the Devil’s in the Details

JOHN HARRISON

THOMAS HEPLER

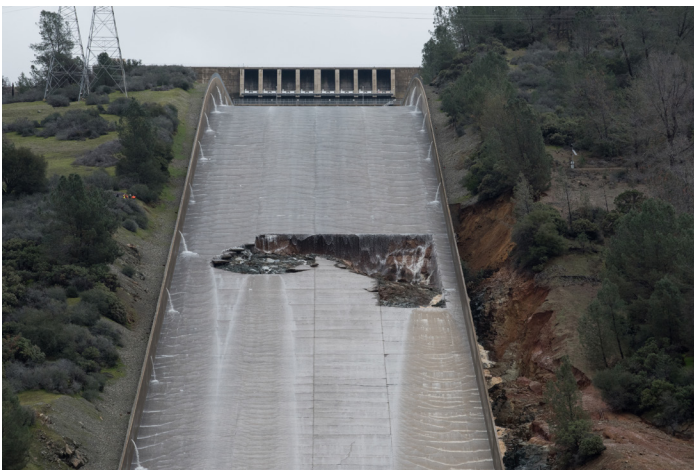
Figure 1: Oroville Dam Primary Spillway after Initial Failure
(Ref. California Department of Water Resources)

The Oroville Dam Spillway Incident Independent Forensic Team (IFT) Report notes that there was no single root cause of the Oroville Dam spillway incident. Rather, the incident was caused by a “complex interaction of relatively common physical, human, organizational, and industry factors, starting with the design of the project and continuing until the incident.”

The physical factors included inherent vulnerabilities in the spillway designs and as-constructed conditions, subsequent slab deterioration, and poor spillway foundation conditions in some locations. The IFT Report concluded that the slab likely failed by hydraulic jacking:

“Water injection through both cracks and joints in the chute slab resulted in uplift forces beneath the slab that exceeded the uplift capacity and structural strength of the slab along a steeply sloping section of the chute. The uplifted slab section then exposed the underlying poor quality foundation rock at that location to unexpected severe erosion, resulting in removal of additional slab sections and additional erosion.”

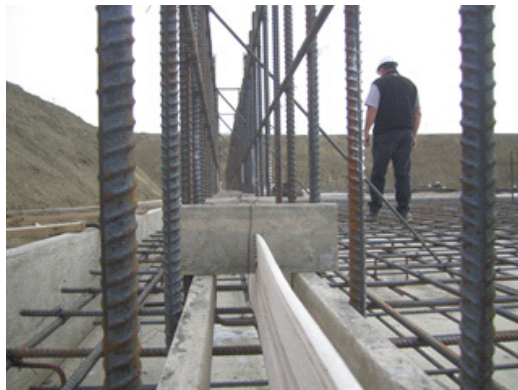
Figure 9: Properly Securing Waterstop (Ref. Sika Greenstreak)

Waterstops should be firmly secured in place to prevent displacement by concrete. Figure 9 shows a photo of good waterstop installation. To decrease the risk of incorrect or incomplete installations, the contract documents should include details of waterstop installation in plan, profile and section. For more complicated installations, an isometric representation of the installation is extremely helpful, whether provided on the contract drawings or required as a submittal.

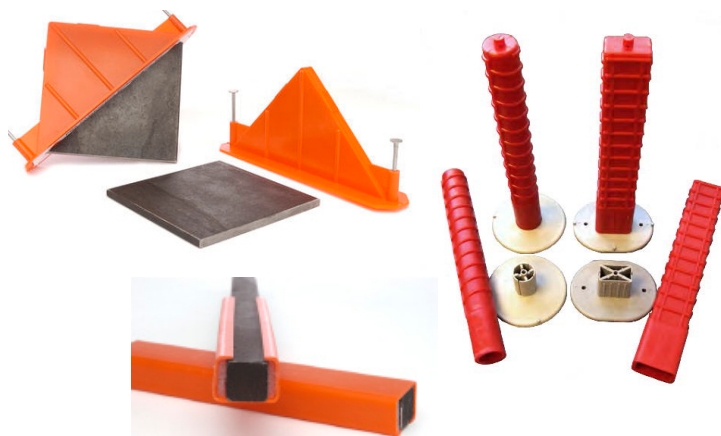
Figure 12: Alternative Doweling Methods

For contraction joints, many doweling options are available to designers. Many allow plastic sleeves to be affixed to the forms and encapsulated in the first placement (Figure 12). After stripping of forms, the steel dowels or plates are inserted into the sleeve prior to the second concrete placement. Care is required when placing concrete around the plastic sleeves, which can easily become dislodged if concrete is placed directly on the sleeve. Some square dowel sleeves contain foam inserts or ridges in the sleeve that allow horizontal movement in two directions as the concrete contracts, but no vertical movement. This helps to reduce the risks and implications of misaligned dowels.
